Soils and Foundations

Slope failures in residential land on valley fills in Yamamoto town

As a result of the 2011 off the Pacific Coast of Tohoku Earthquake, five slope failures occurred in a residential area on artificial valley fills in Taiyo New Town, Yamamoto, Miyagi Prefecture. The site was constructed by leveling a hilly area and using the cut materials as fill for the valleys to provide foundation ground for houses. The fill material was sandy and was derived from the weathering of tuffaceous sandstone which had formed the natural ground. Each of the five slope failures was observed to have occurred either at the edge of the artificial valley fills or within the embankment sections that had been widened for road construction. Laboratory tests show that the fill, which had a fines content of $F_c=20\%$, had a very low liquefaction resistance, which further decreased with the application of initial shear stress. A pseudo-static slope stability analysis, using conventional strength parameters, could not explain the slope failure at one of the sites that failed, but it could explain the slope failure when the dynamic strength was used to represent the soil strength at the slip

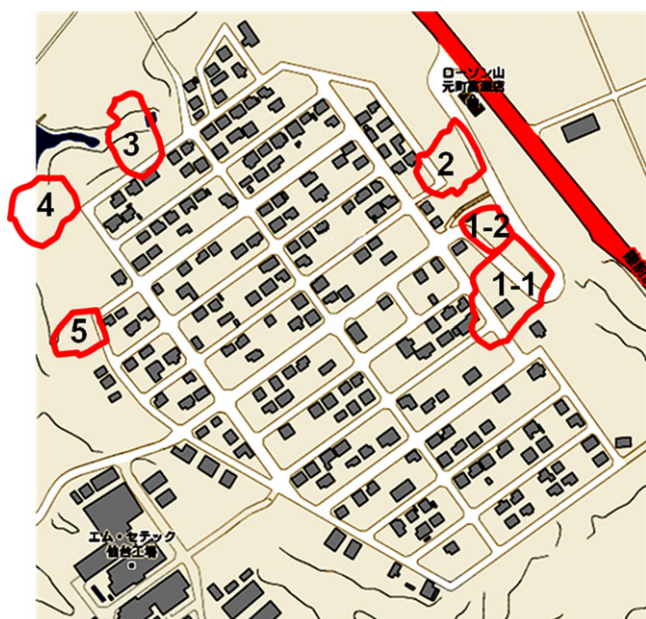
Following the 2011 earthquake and its major aftershocks, slope failures occurred at five sites within the Taiyo New Town housing site. The locations of the slope failures are shown in Fig. 5. These failed or slid blocks were sequentially

Comparing the locations of the failed blocks at the housing site (Fig. 5) with the foundation ground map shown in Fig. 2, it is clear that failed Blocks 1 and 2 occurred in the section of fills which was widened to construct the road, while Blocks 3, 4 and 5 occurred along the edge of the valley fills. This suggests that the fill material, rather than the natural ground, was involved in the slope failures.

Fig. 5. Location of failed slopes at Taiyo New Town residential site.

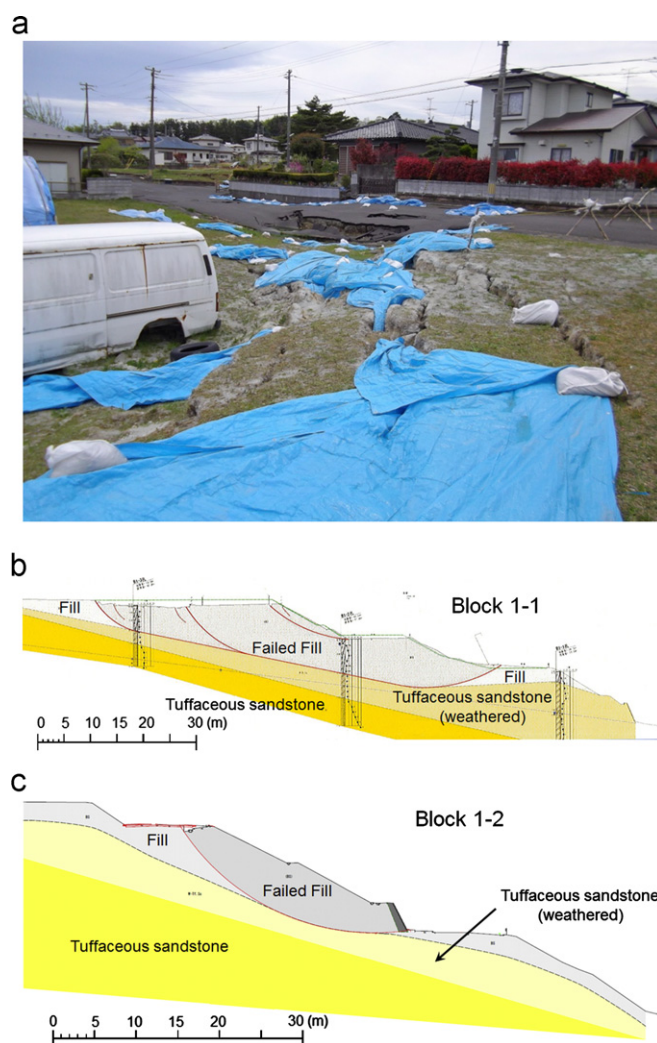
Block 1 consisted of two slope failures. The first sliding block, Block 1–1, caused settlement at the crest and laterally flowed down the sloping ground, as shown in Fig. 6(a). As a result, a house located on the laterally moving ground tilted and a 1-m-high vertical offset was created at the crest. The block was about 54 m wide, 80 m long and 6.7 m deep. Extensional cracks were also observed in the ground and the road pavements. The adjacent failed block, Block 1–2, was smaller in scale (40 m wide, 31 m long and 6.3 m deep) and induced cracking in the road as the sliding mass moved. In both cases, the surface of the road's downslope was pushed up as a result of the movement. The embankment was widened at this site for the purpose of road construction. Fig. 6(b) and (c) show the cross-sectional profiles of Blocks 1–1 and 1–2, respectively.

Fig. 6. (a) View of crest at failed slope in Block 1-1 showing extensional cracks and vertical offsets, (b) cross-sectional profile of failed slope in Block 1-1 and (c) cross-sectional profile of failed slope in Block 1-2.

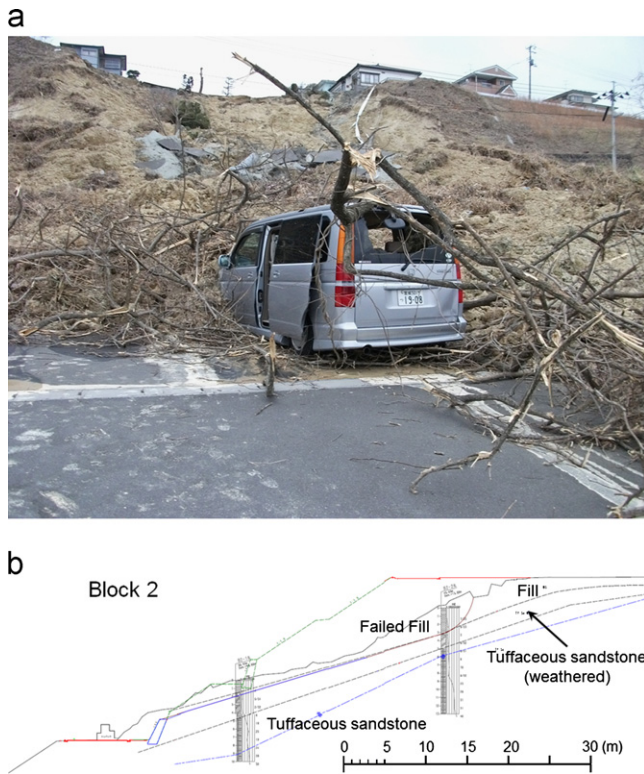
the parking lot adjacent to a convenience store (see Fig. 7(a)). It is apparent that the failure was confined to the upper layer consisting of fill material. A house located at the crest of the sliding mass was partially destroyed, while the roads positioned at the top and the midway of the slope were totally destroyed, sending cracked pavements downward. The cross-sectional profile of the slope is shown in Fig. 7(b). Block 2 is also located in a section of the embankment which was widened to accommodate the road. The retaining wall in this area (adjacent to the location of the left boring log in the figure) collapsed as a result of the failure. The bottom retaining wall (to the left of the figure near the main road) remained standing, but was covered with debris. Just to the north of the failed slope and down on the main road, a reinforced retaining wall missed the landslide. This particular retaining wall was constructed in 2008 when the section failed following a heavy rainfall; the retaining wall was not damaged by this earthquake.

Fig. 7. (a) View of slope failure in Block 2 from parking lot below and (b) cross-sectional profile of failed slope in Block 2.

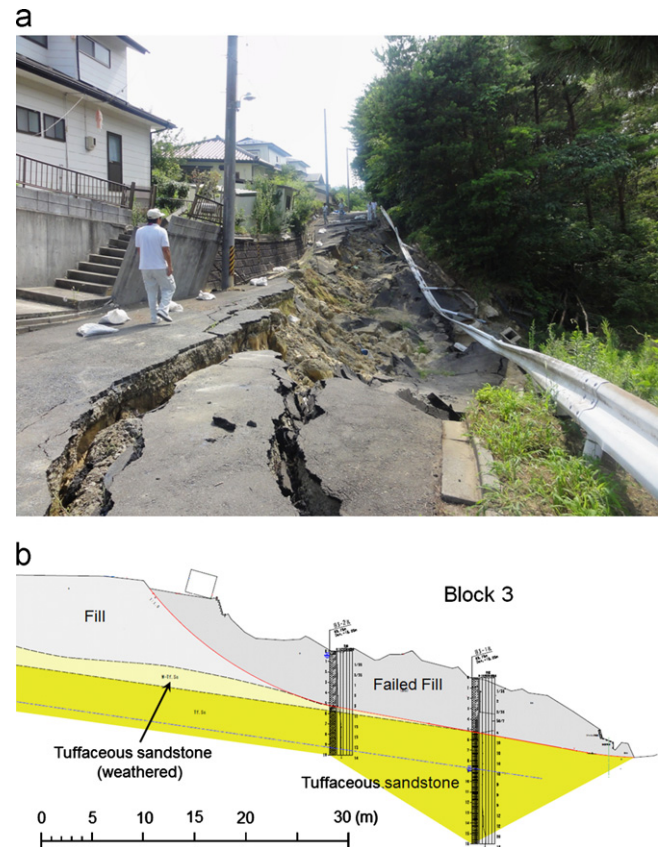
a portion of the road embankment collapsed over a distance of 15–20 m, and the fill materials flowed down the slope. Fig. 8(a) shows the condition of the failed slope, while Fig. 8(b) depicts the cross-sectional profile of the slope. A house adjacent to the road and located on top of the crest tilted, together with the fence and road railings. Vertical offsets in the order of 20–30 cm were observed near the house, exposing its foundation and leaving the house hanging precariously on its edge. Extensional ground cracks were also observed near two other houses. Moreover, the debris blocked drainage channels installed in the middle of the slope. The end of the embankment was reinforced with gabions; however, the gabions failed together with the embankment.

Fig. 8. (a) View at top of failed slope in Block 3 (at least three houses were affected by movement and extensional cracks that developed) and (b) cross-sectional profile of failed slope in Block 3.

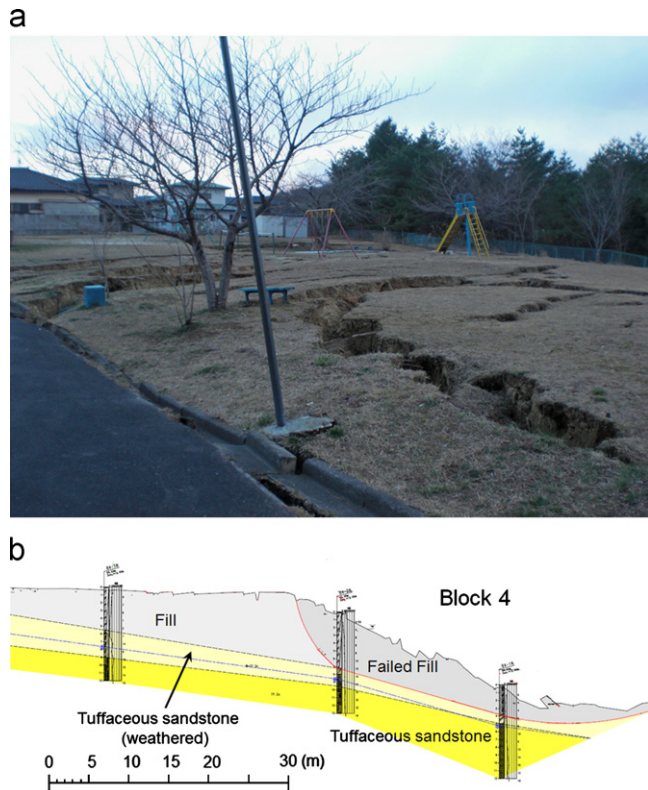
toe of the embankment, collapsed as a result of the failure. Fig. 9(b) illustrates the estimated cross-sectional profile of the slope.

Fig. 9. (a) Extensional cracks at park located on crest of failed slope in Block 4 (failure was toward right of photo) and (b) cross-sectional profile of failed slope in Block 4.

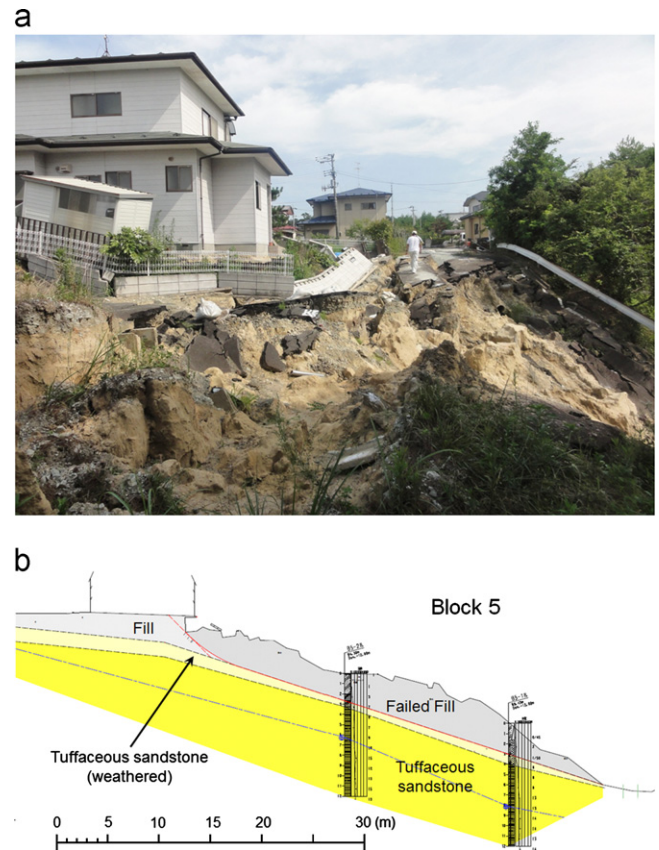
Fig. 10(a) shows the fifth failed block, Block 5, in the western section of the site. A two-story house on top of the slope was damaged due to vertical offsets and extensional failure resulting from slope movement. The house was tilted, exposing its foundation. Fences, railings and other lightweight structures also collapsed. The road on the crest of the failed slope subsided and the debris covered the drainage channels. Portions of road pavements, as well as damaged sewage facilities, were seen among the flowed debris. The soil debris was observed to consist of sand and sandy soil, representing the material of the fill. Fig. 10(b) shows the cross-sectional profile of the slope.

Fig. 10. (a) View of slope failure in Block 5 (house hangs precariously on edge of failed slope) and (b) cross-sectional profile of failed slope in Block 5.

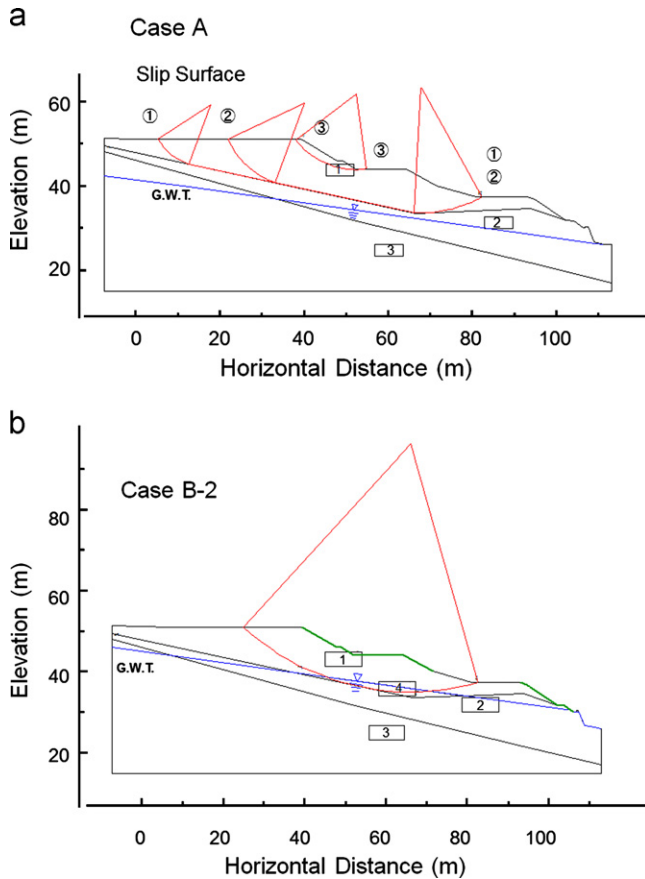
The results of the analysis are summarized in Table 4 for all the cases considered, in terms of yield acceleration k_y , necessary for the limit equilibrium condition ($F_s=1.0$), while typical model slopes and critical slip surfaces are shown in Fig. 19. For cases with composite failure surfaces, the values for the slip surfaces employed here are also indicated. Considering that the results of the above-mentioned SHAKE analysis showed k_h values of 0.35–0.37, the only condition where k_y is less than these values is the case involving the use of the dynamic strength at the slip surface (Case B-2'); all other cases using conventional strength parameters resulted in values of k_y that are higher than those induced by the 2011 earthquake. For the conventional analysis to hold, k_h should be at least 0.39 or a PGA on top of the fill should be 1,570 cm/s² (based on Noda's equation); this value is deemed too large.

Thus, based on the calculations presented above for the Block 1–1 site, it appears that the slope failure in Taiyo New Town can be attributed to the liquefaction of the fill, especially near the interface between the top fill layer and the highly weathered tuffaceous sandstone. With the development of excess pore water pressure, the fill underwent large deformation during the intense and prolonged shaking induced by the gigantic Tohoku earthquake. As mentioned earlier, the location of the groundwater table during the earthquake was unknown. It is possible that the groundwater table during the earthquake was above the boundary between the original ground and the fill, making the generation of excess pore water pressure during shaking viable.

Fig. 19. Model slope with critical failure surfaces. (a) Case A (no water table with composite failure surfaces) and (b) Case B-2 (with water table and circular slip surface).

Note that a slope stability analysis was performed on only one block and that further analyses are recommended for the other four sites which failed for the purpose of clarifying that liquefaction was indeed the main cause of the slope failures in Taiyo New Town. In addition, since the PGAs recorded during this event far exceed the database used in Noda's method of estimating the seismic coefficient, further studies are suggested in order to find an appropriate method for estimating k_h under large peak ground accelerations.
